SunPointe at Lakewood Estates II Condominium Association, Inc. 5885 W. Asbury PI. Lakewood, CO 80227

Level 1, Platinum Reserve Analysis Report Period – 01/01/18 – 12/31/18

Client Reference Number - 9616 Property Type – Condominiums Final Version

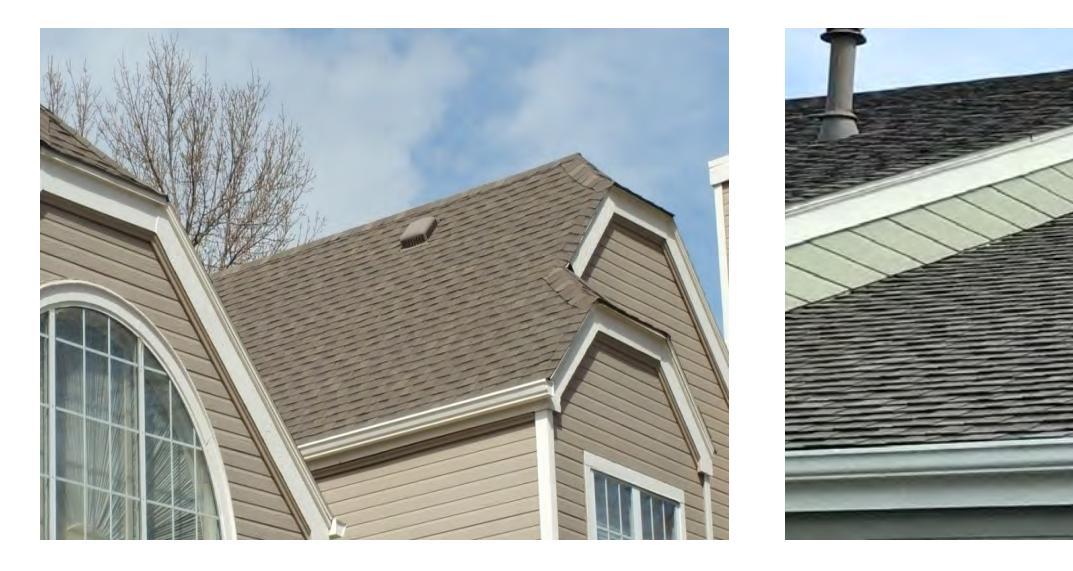
Comp #: 105 Comp Shingle Roof - Replace (1)

- This roof appears to be a "50-year" rated shingle.

- Reserve funding includes complete tear off and replacement for 50% (1,471 Squares) of total roofs other than building 18.

Location:	See General Notes		
Quantity:	Approx. 1,471 Squares		
Life Expectancy:	20	Remaining Life: 11	
<i>Best Cost:</i> \$500/square; Estir	\$73 nate t	5 ,500 to remove and replace	
Worst Cost:	\$809	9,050

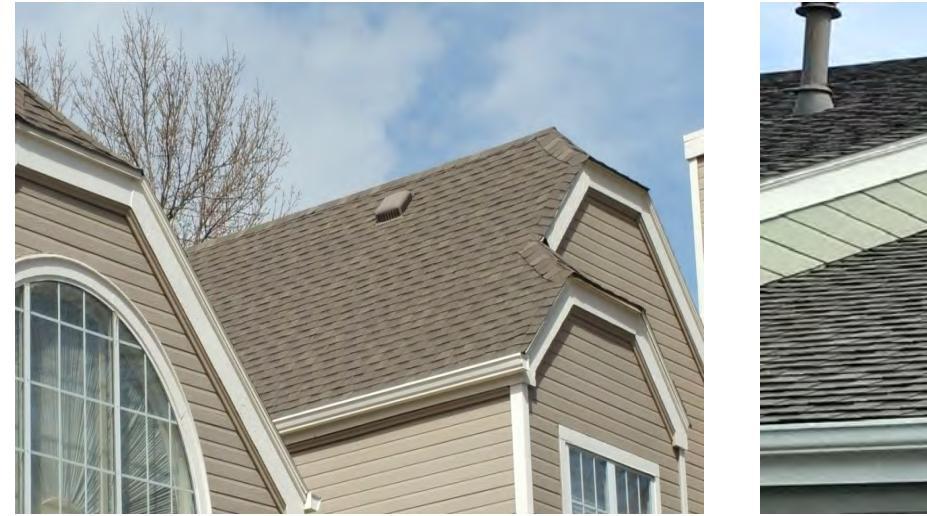
Comp #: 106 Comp Shingle Roof - Replace (2)

- Reserve funding includes complete tear off and replacement for 50% (1,471 Squares) of total roofs other than building 18.

Location:	See General Notes		
Quantity:	Approx. 1,471 Squares		
Life Expectancy:	20 Remaining Life: 13		
<i>Best Cost:</i> \$500/square; Estir	\$735,500 mate to remove and replace		
Worst Cost:	\$809,050

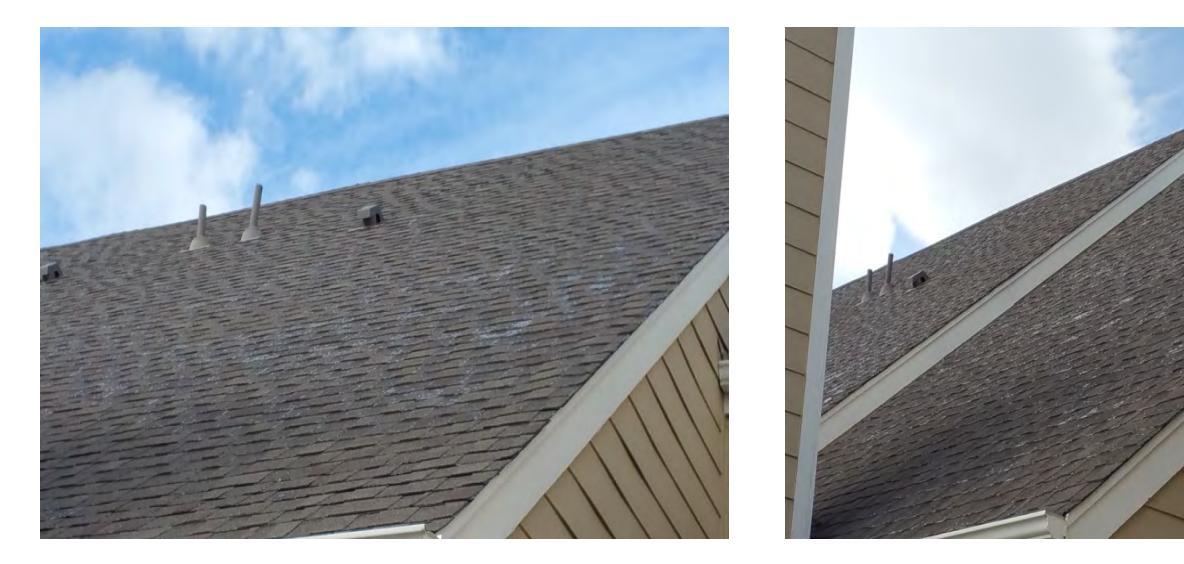
Comp #: 107 Comp Shingle Roof - Replace (3)

- The roof on Building 18 is in poor condition. There were many signs of advanced deterioration and loss of granules.
- Therefore, the remaining useful life has been adjusted to reflect the current condition of the roof.

Location:	Building 18		
Quantity:	Approx. 85 Squares		
Life Expectancy:	20	Remaining Life: 0	
Best Cost:	\$42 ,	500	
\$500/square; Estimate to remove and replace

Worst Cost:\$46,750\$550/square; Higher estimate for more labor costs

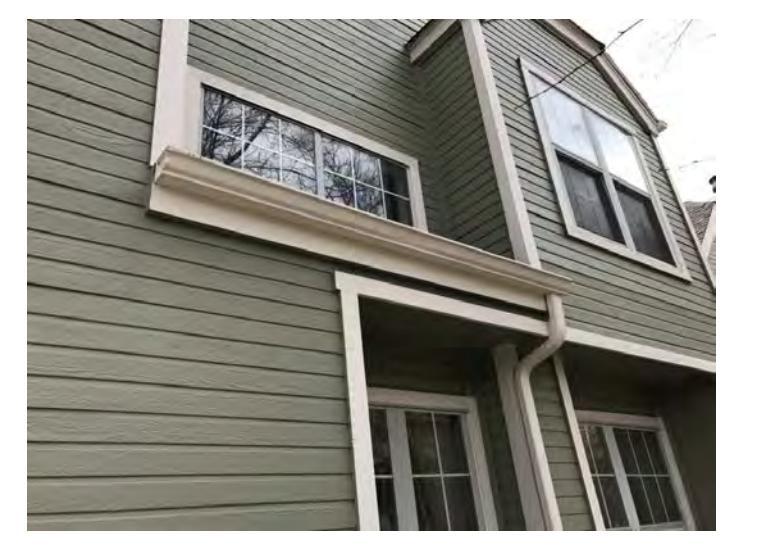
Comp #: 120 Gutters/Downspouts - Replace (1)

- It is typical to replace gutters and downspouts at the same time as roofing materials.

- We recommend cleaning debris out of lines at least once a year to prevent clogging and moisture retention that can lead to advanced deterioration.

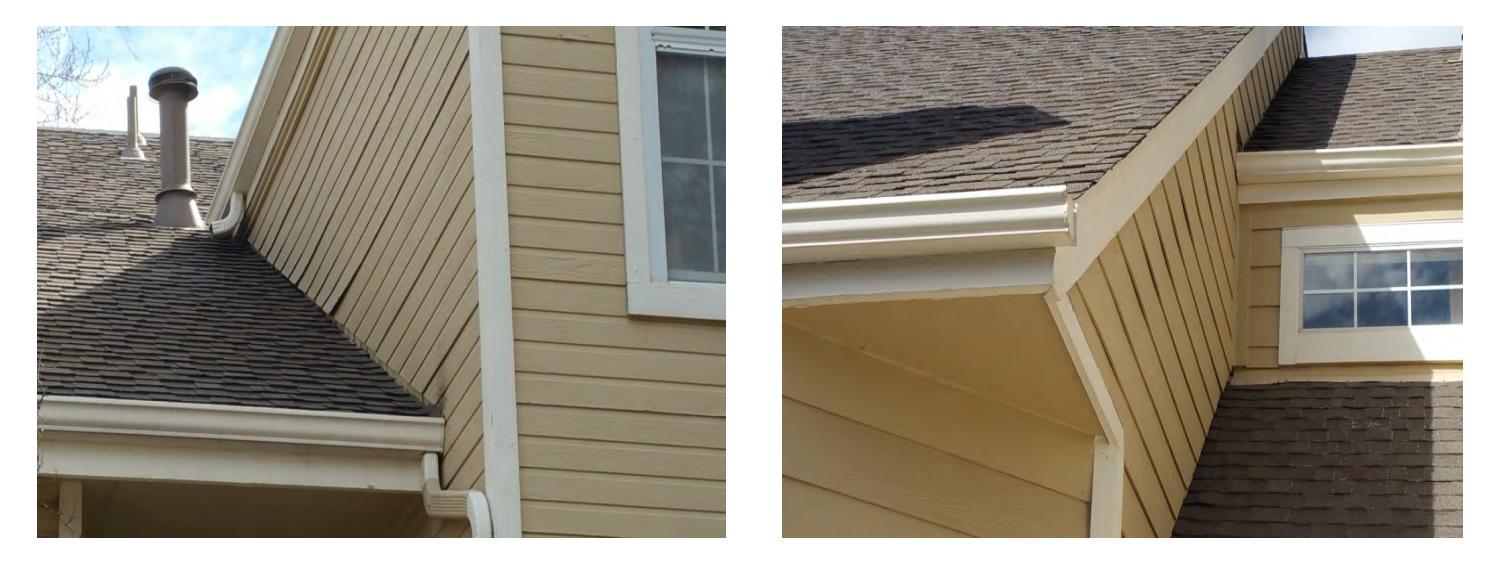
Comp #: 122 Gutters/Downspouts - Replace (3)

- It is typical to replace gutters and downspouts at the same time as roofing materials.

R/G: Approx. 455 LF, D/S: Approx. 410 LF Project History: - 1999: Replaced

- We recommend cleaning debris out of lines at least once a year to prevent clogging and moisture retention that can lead to advanced deterioration.

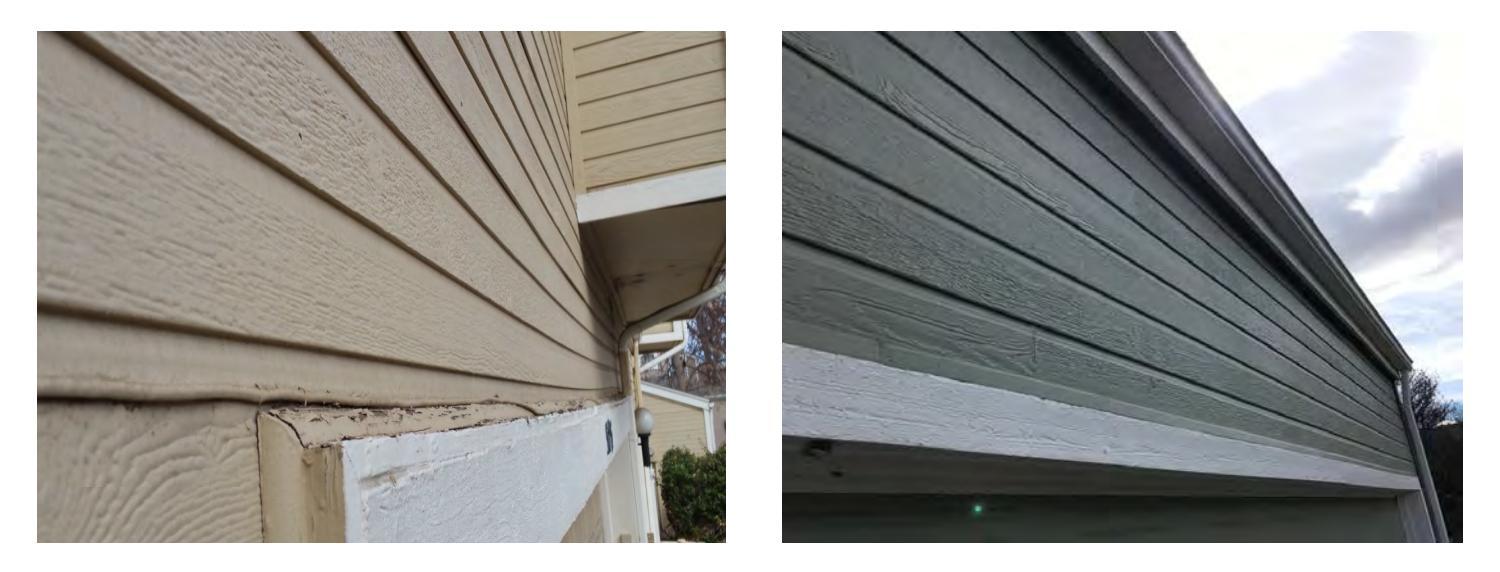
Comp #: 302 Siding - Major Repairs (2018)

- The siding on most of the buildings is a hardboard product and there were several areas where the siding was warped and showed signs of deterioration.

- We suggest establishing Reserve funds for major repairs every painting cycle due to the condition of the siding.

If the amount of repairs decreases in the future, the frequency of repairs can be moved to every other painting cycle.
The remaining life is based on the observed conditions at the time of our site evaluation and the timing of the next paint job.

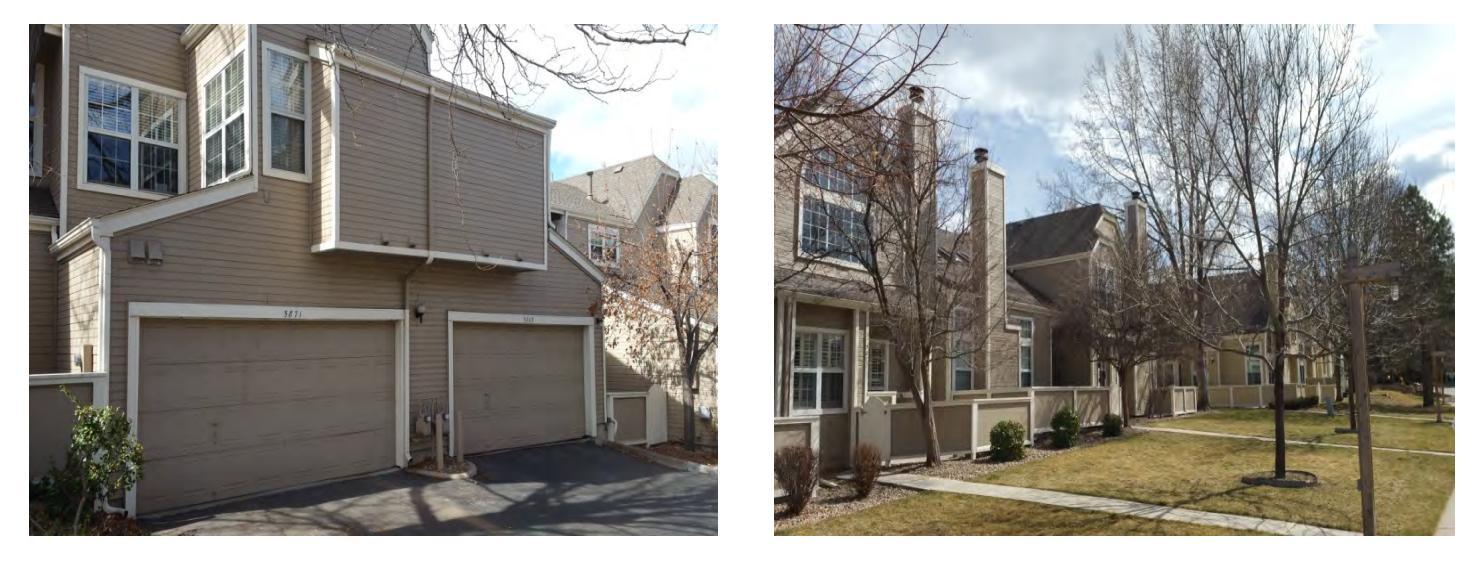
Comp #: 303 Siding - Major Repairs (2019)

- The siding on most of the buildings is a hardboard product and there were several areas where the siding was warped and showed signs of deterioration.

- We suggest establishing Reserve funds for major repairs every painting cycle due to the condition of the siding.

If the amount of repairs decreases in the future, the frequency of repairs can be moved to every other painting cycle.
The remaining life is based on the observed conditions at the time of our site evaluation and the timing of the next paint job.

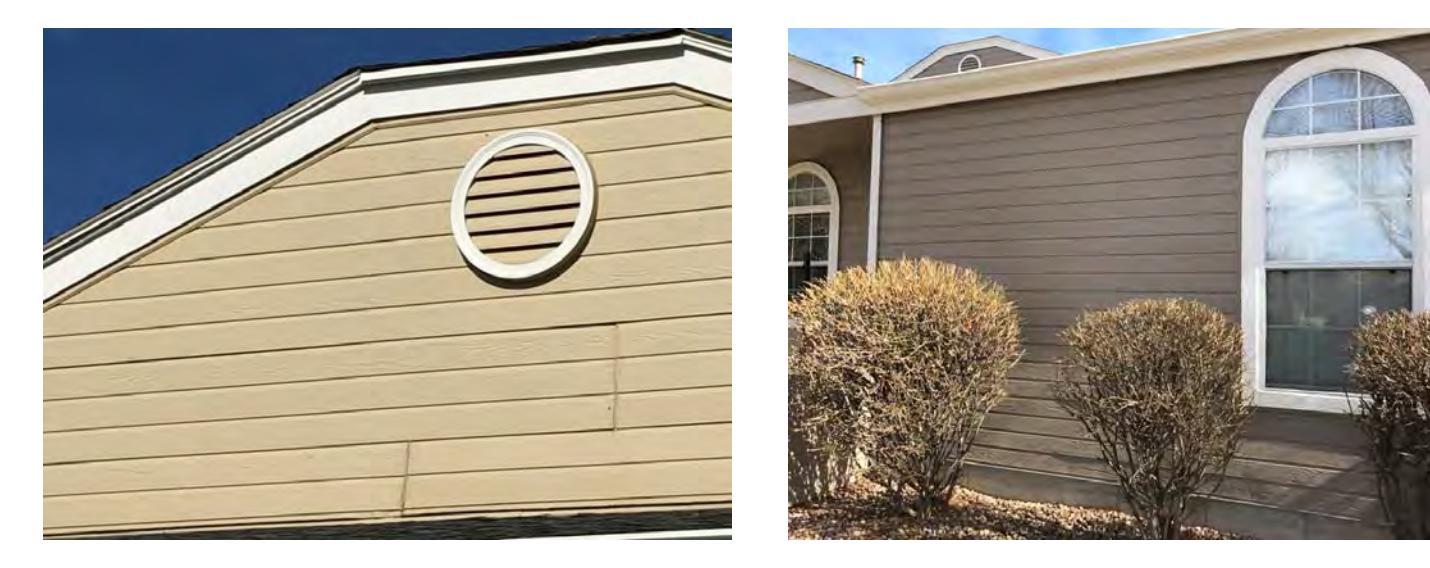
Comp #: 304 Siding - Major Repairs (2020)

- The siding on most of the buildings is a hardboard product and there were several areas where the siding was warped and showed signs of deterioration.

- We suggest establishing Reserve funds for major repairs every painting cycle due to the condition of the siding.

If the amount of repairs decreases in the future, the frequency of repairs can be moved to every other painting cycle.
The remaining life is based on the observed conditions at the time of our site evaluation and the timing of the next paint job.

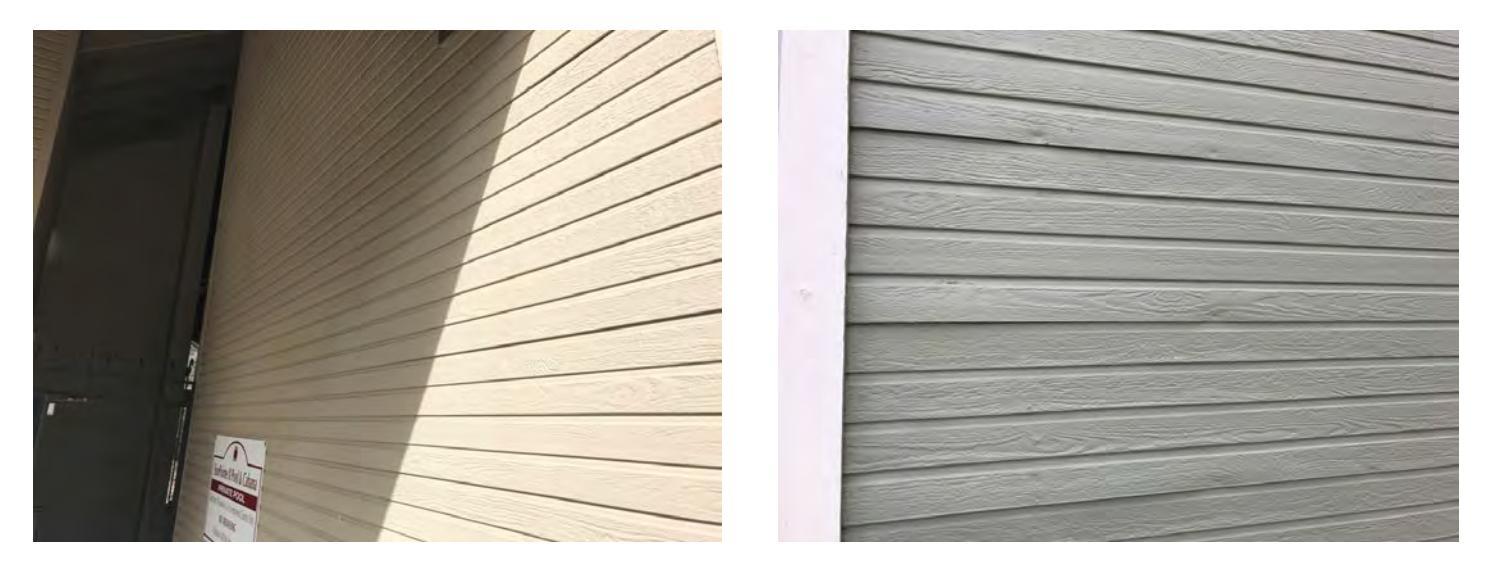
Comp #: 305 Siding - Major Repairs (2021)

- The siding on most of the buildings is a hardboard product and there were several areas where the siding was warped and showed signs of deterioration.

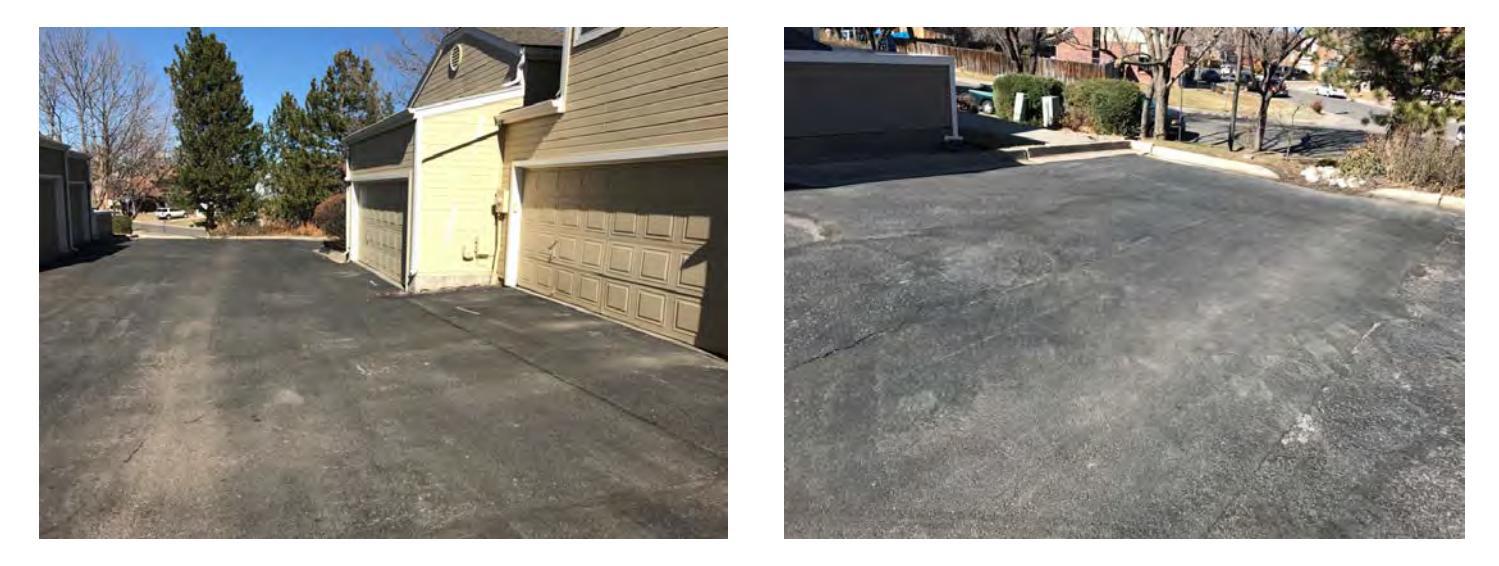
Comp #: 402 Asphalt - Surface Application

- It is important to maintain a proper seal cycle to protect the integrity of the asphalt and prevent extensive cracking, development of potholes, and loss of emulsion, which will lead to advanced deterioration.

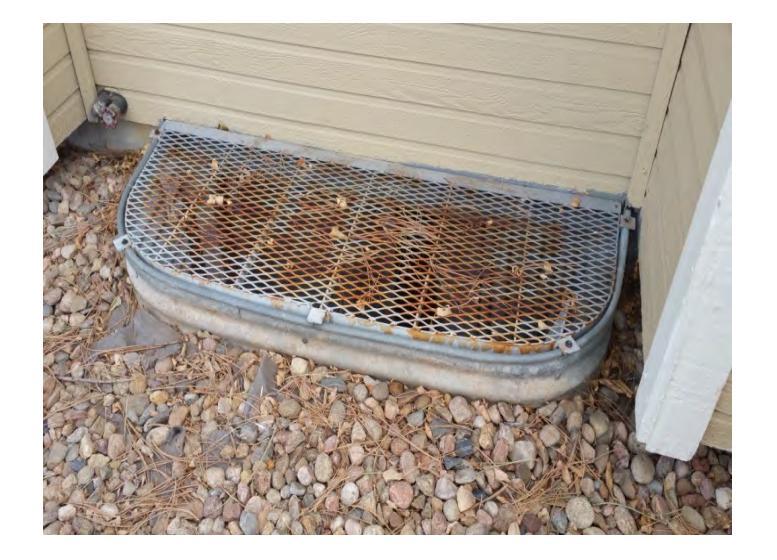
Comp #: 509 Window Wells - Replace

- Due to unpredictable life expectancy, Reserve funding is not required.
- At this time, we recommend replacing on an as needed basis with general operating funds.
- If periodic replacement becomes necessary, we can add funding in future Reserve Study updates.

Location:	See General Notes		
Quantity:	Approx. (242) Window Wells		
Life Expectancy:	N/A	Remaining Life:	
Best Cost:	\$0		
Worst Cost:	\$0		
Source of Information:

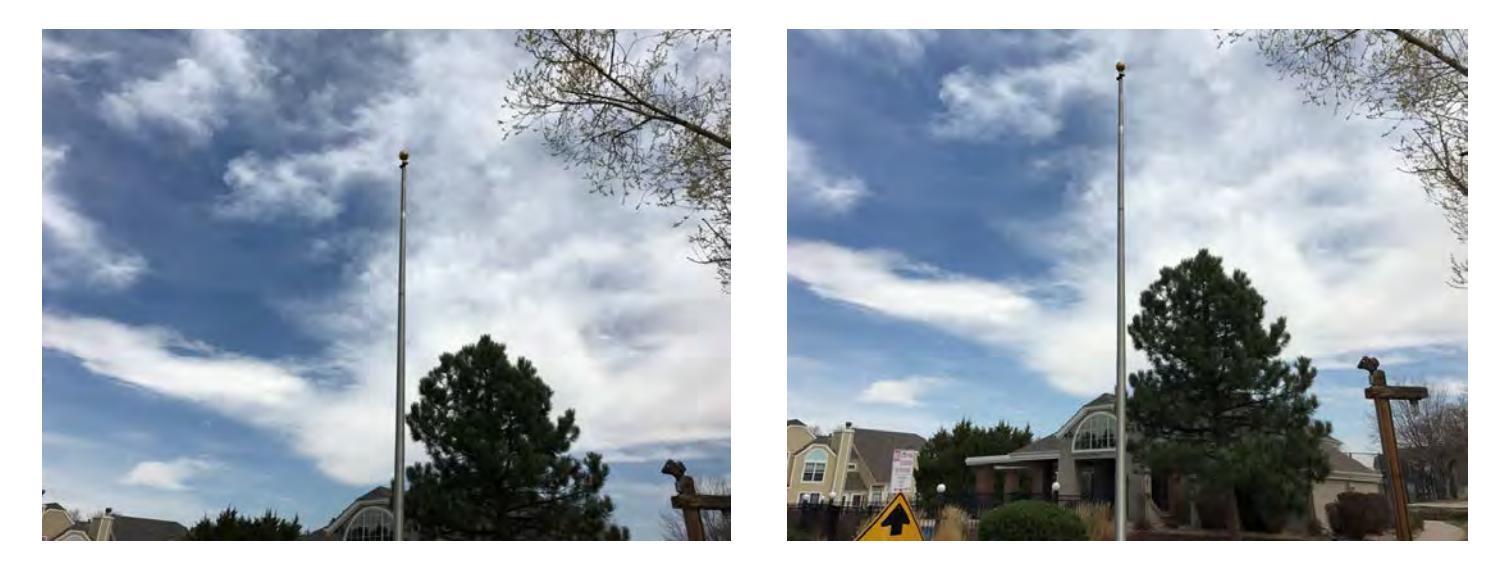
Comp #: 810 Flagpole - Replace

- There was no flag on the flagpole at the time of the site observation, it appeared to be in good condition.
- The individual replacement cost of the flagpole does not warrant Reserve funding.
- Repair and replace the flagpole on an as needed basis with operating funds.

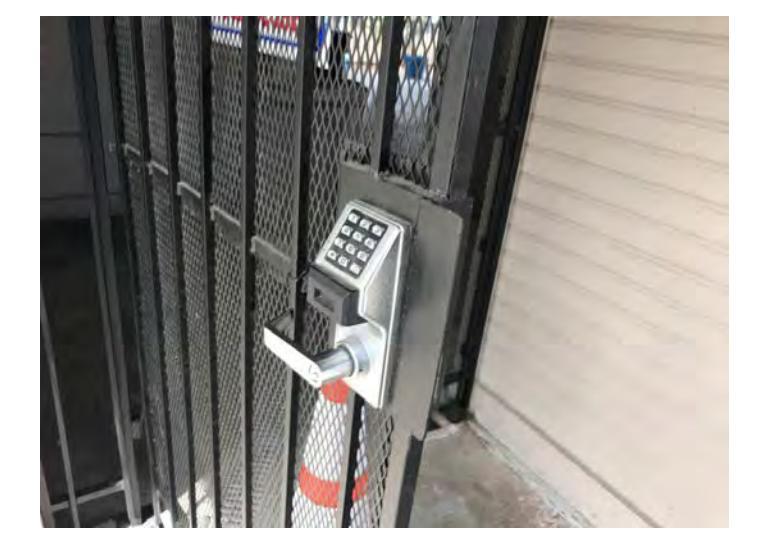
Comp #: 908 Electronic Door Locks - Replace

- The key pad locks at the clubhouse and tennis courts had no reported issues.
- The individual replacement cost of these locks does not warrant separate Reserve funding at this time.
- Replace as needed with operating funds.

Location:	Pool Building and Tennis Courts
Quantity:	(4) Key Fob Locks
Life Expectancy:	N/A Remaining Life:
Best Cost:	<i>\$0</i>
Warst Cast	¢0
Worst Cost.	φυ
Source of Information:

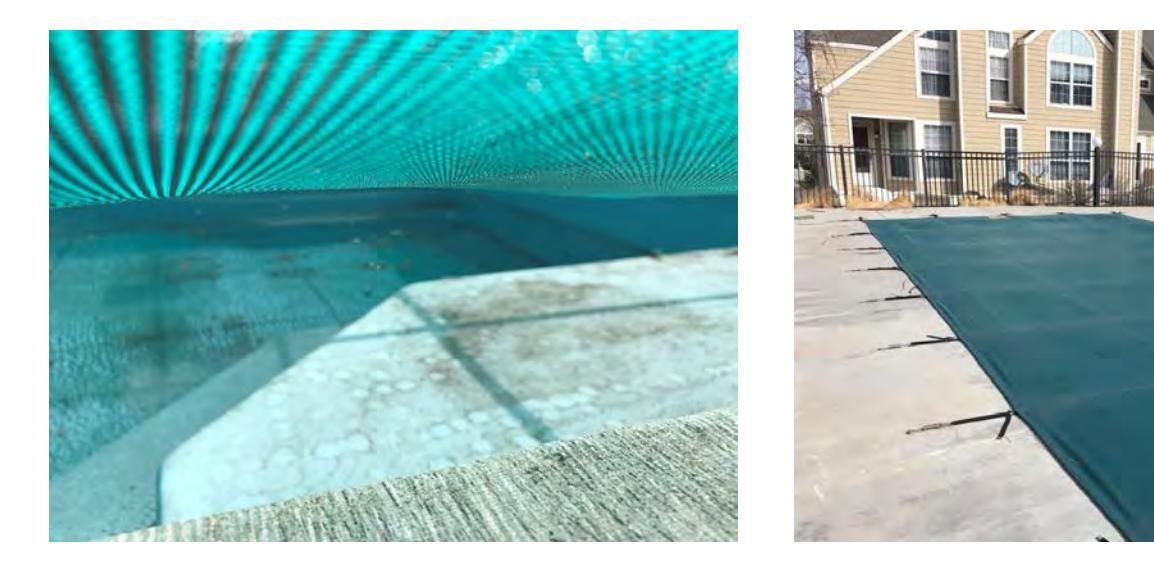
Comp #: 1101 Fiberglass Pool - Replace

- The pool was covered at the time of the site observation with no reported issues with the pool.
- Fiberglass pools generally have a life expectancy of 25 30 years with proper maintenance.

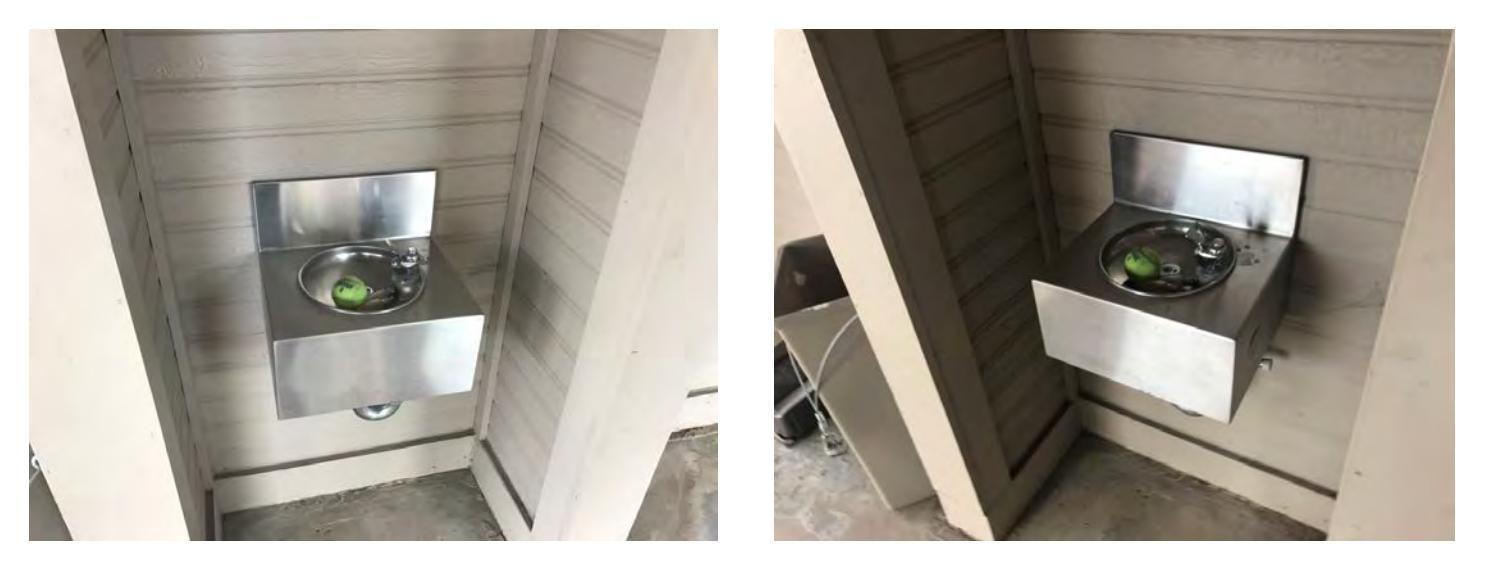
Comp #: 1304 Drinking Fountain - Replace

- Drinking fountain appeared to be in good condition at the time of the site observation with no reported issues.
- Due to the minimal replacement cost of individual drinking fountains reserve funding is not appropriate.
 - Repair and replace individual drinking fountains as necessary as an operating expense.

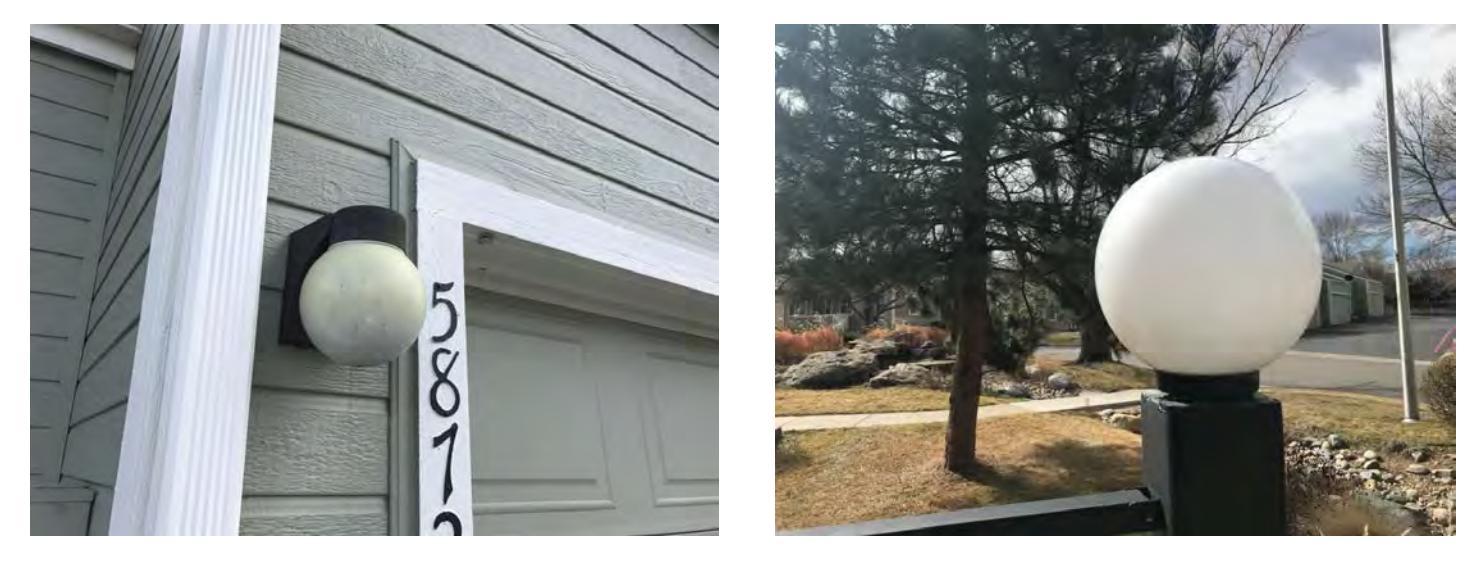
Comp #: 1602 Exterior Wall Mount - Replace

- Could not inspect light function due to time of observation, no reported issues with the lights.

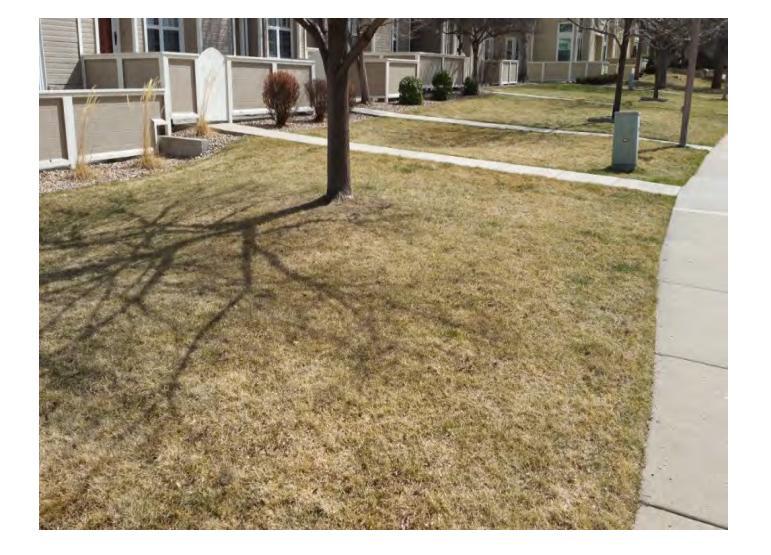
Comp #: 1701 Irrigation System - Major Repairs

- The funding on this line item is for major repairs and is not to be interpreted as complete irrigation system replacement.

Location:	Throughout Property
Quantity:	Extensive
Life Expectancy:	5 Remaining Life: 2
Best Cost:	\$20,000
Estimate for major	repairs and renovating system
<i>Worst Cost:</i> Higher estimate fo	\$25,000 r more labor
Source of Informat	ion: Cost Database

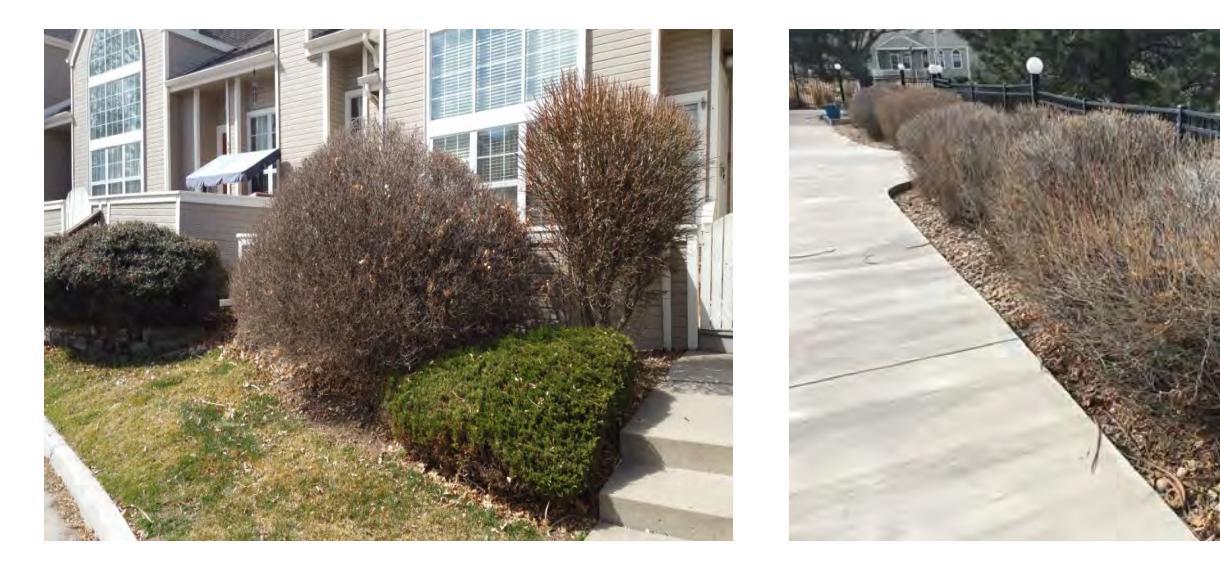
Comp #: 1801 Groundcover - Replenish

- This line item, similar to irrigation repairs, is for projects that lie outside the scope of routine maintenance.

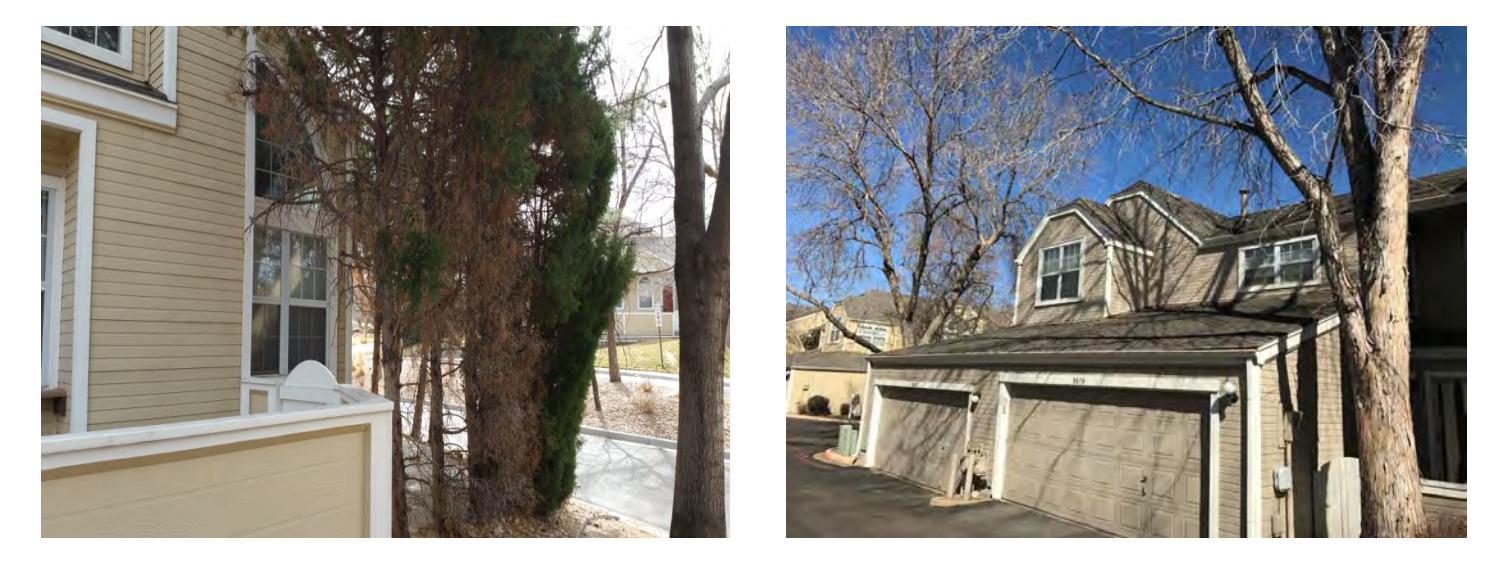
Comp #: 1804 Tree - Replacement/Major Maintenance

- It is very difficult to predict a replacement cycle for trees as there are several factors such as disease, infestation of insects, heavy snow storms, etc. can all attribute to eventual tree replacement.
